Entrapped Moisture...

But This Is a LEED® Gold Building!

By Remo Capolino, RRC, PE

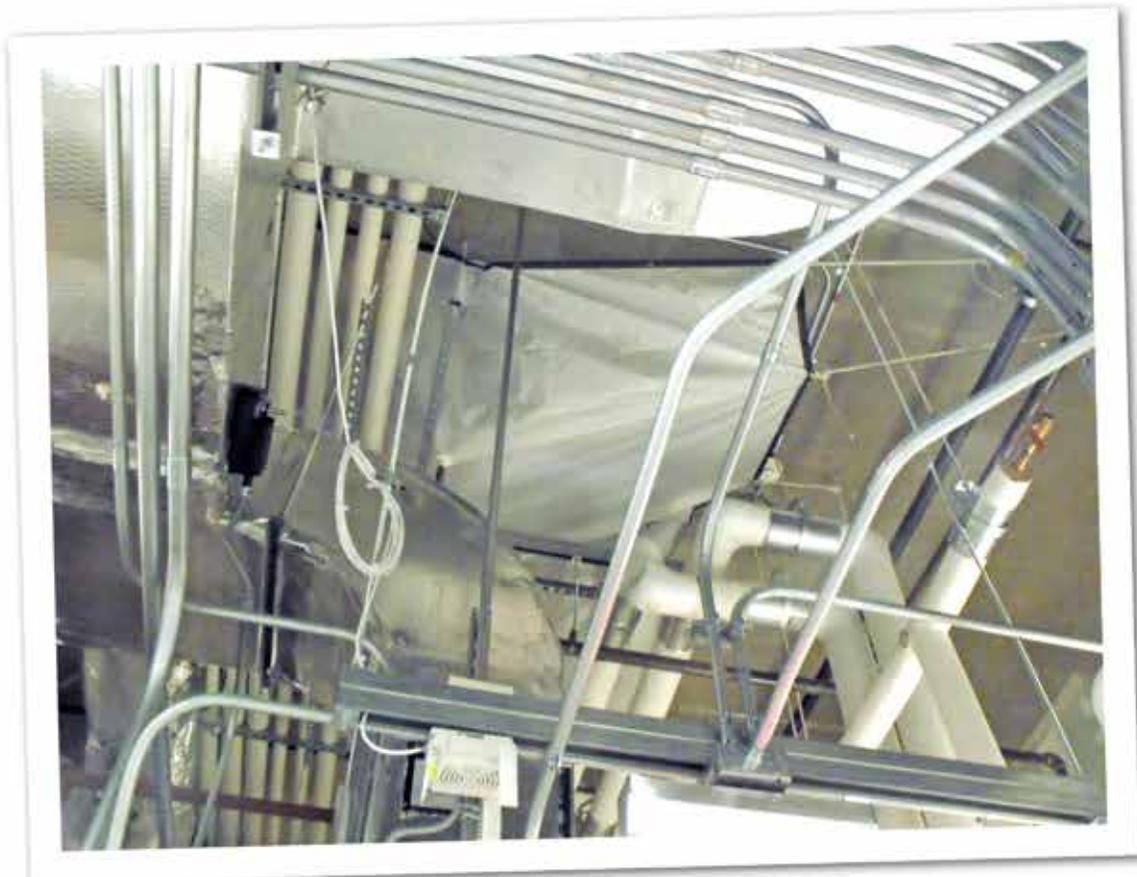
The building in question is a multistory LEED® Gold educational building on a university campus in the Northeastern United States. The structure was completed circa 2006, and the top floor is a very congested, warm, mechanical floor (Figure 1). The roof deck is a 14-in.-thick concrete slab covered with iso insulation that tapered from 1.5 to 9 inches, with all layers set in foam adhesive with a fully adhered, fleece-backed, reflective, white, single-ply roof membrane that, of course, utilized a water-based, low-VOC, LEED®-friendly bonding adhesive. The roof was relatively free from penetrations, with the exception of a few roof curbs, vent

Figure 1 – Overview of congested mechanical room space directly below the roof deck.

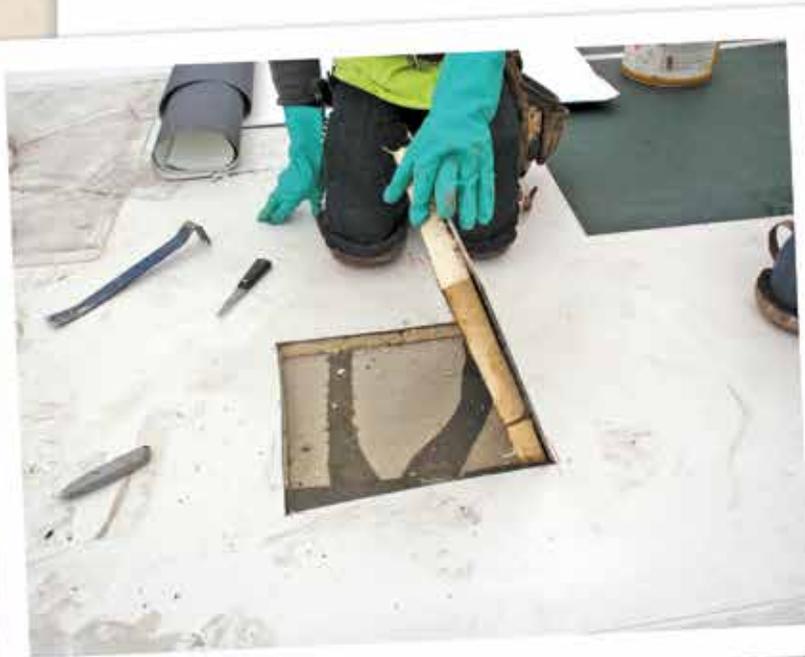
At areas where the insulation was thin, the conditions of the insulation and membrane were similar: The single layer of insulation was debonded from both the concrete deck and the single-ply membrane. The mode of failure at both sides of the insulation board was a cohesive failure of the iso board fiberglass-reinforced paper facers (*Figures 3 and 4*). At locations where the insulation was a single layer, organic growth was observed at varying degrees (from moderate to complete) on the paper facer of the insulation board (*Figure 5*).

Figure 3 – Cohesive facer failure. Note facer material on adhesive ribbons on deck but no foam core visible.

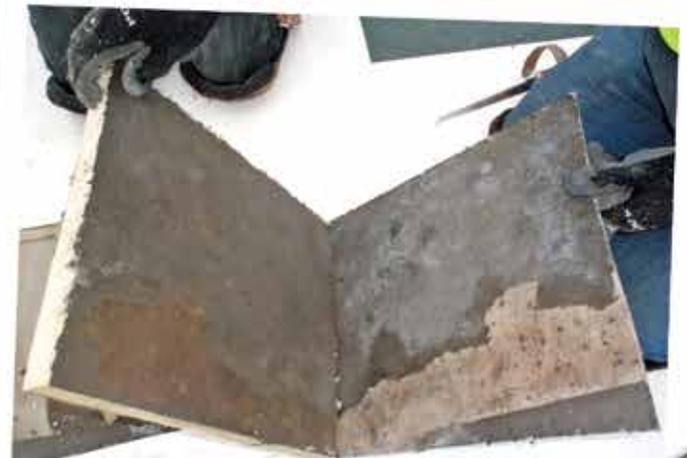
Figure 4 – Mostly (80%+) cohesive failure of facer with remnants of facer on iso board and bottom side of fleece-backed membrane.

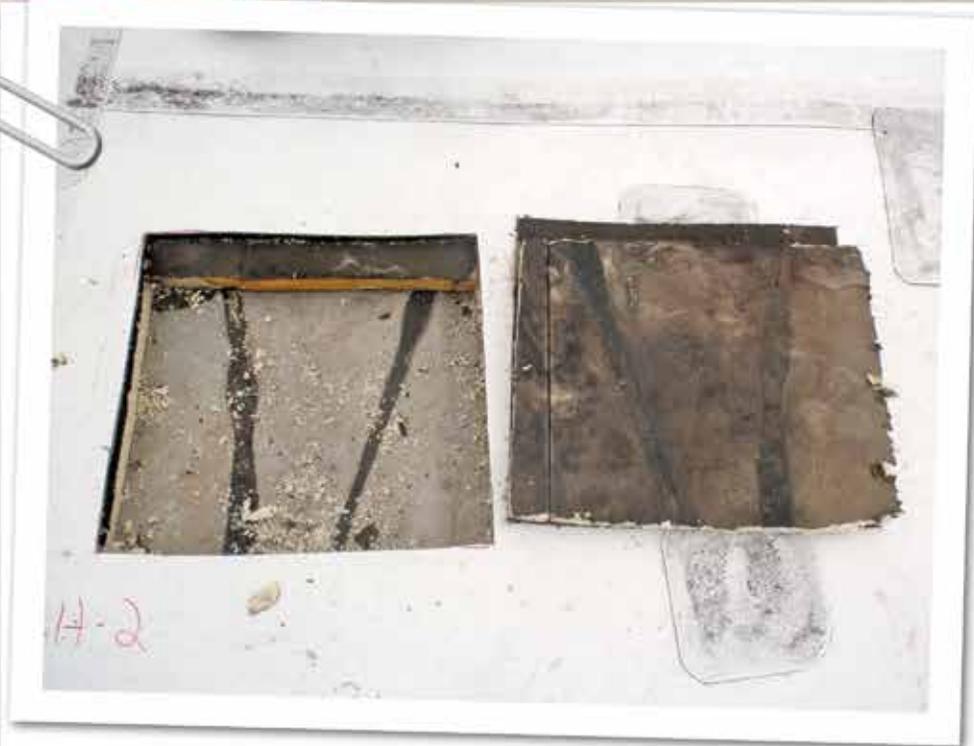
Figure 5 – Organic growth on bottom facer

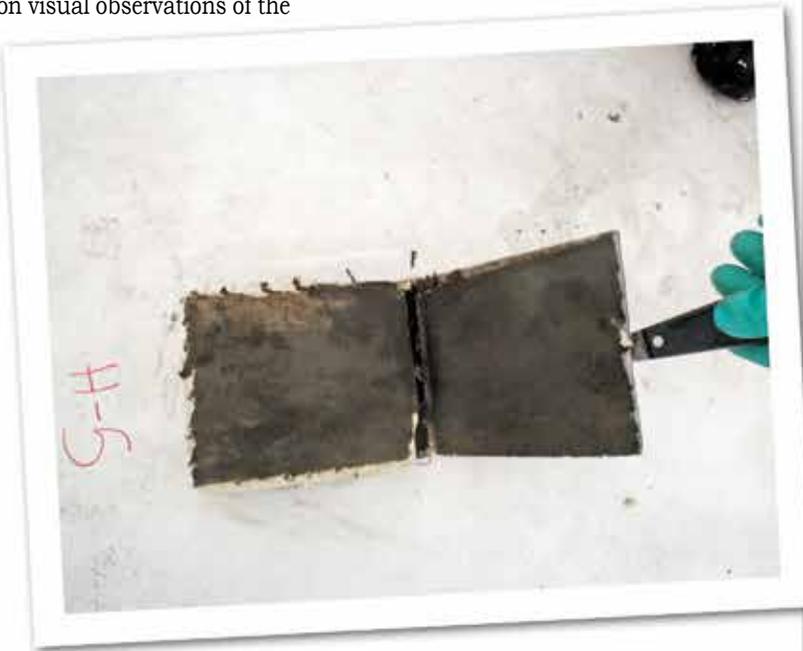
boards were well bonded to the concrete deck. The bond, however, between the single-ply membrane and insulation had failed, with the mechanism of failure being cohesive failure of the insulation paper facer (*Figure*

6). The interface between the top layer and underlying layer of insulation was inspected, and no adhesive was found; however, signif-

Figure 6 – Cohesive failure of iso board top facer, leaving facer remnants on iso board and fleece-backed membrane.

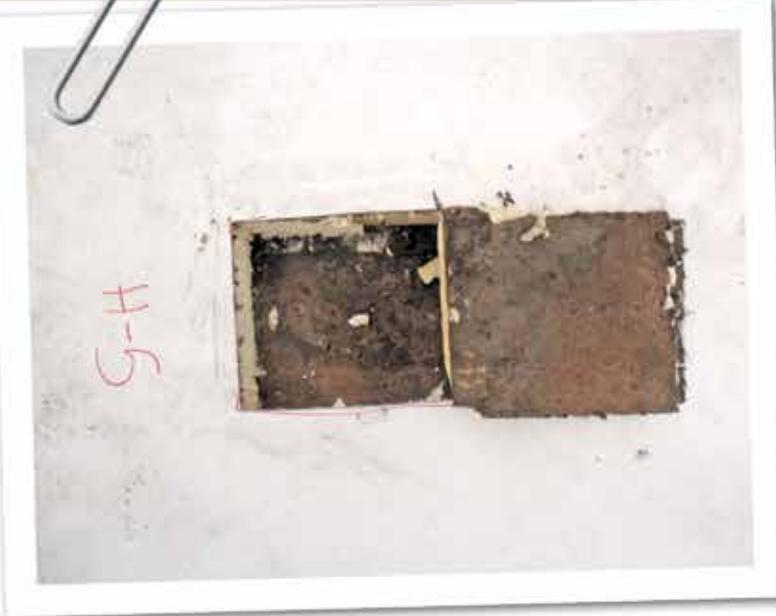
icant organic growth was noted on both paper facers at this level (*Figure 7*). To summarize, the failures observed at the areas with three layers of insulation were similar to the areas with one layer of insulation, in that cohesive insulation facer failures were noted in the top insulation layer and significant organic growth on the paper facers was also observed.

Figure 7 – Organic growth on iso facers.

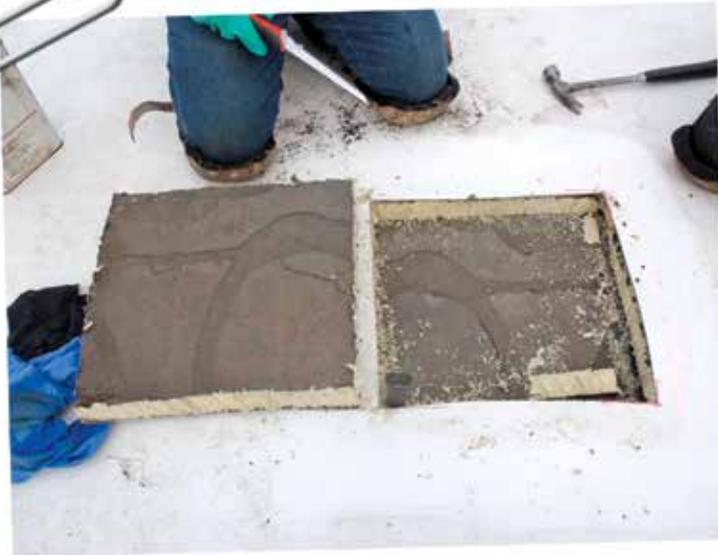
A condition of interest after laboratory testing was the mode of failure of the insulation boards during removal from the roof. The boards were adhered; however, forced removal resulted in cohesive failure of the iso facers and did not cause the facer to peel off of the foam core (Figure 8).

Figure 8 – Removal of insulation at area with several layers. This appeared dry when compared to areas with a single layer. Note removal of top insulation board resulted in cohesive failure of facers.
