Doing It Right the *Second* Time –

Designing Minimally Invasive, Cost-Effective Solutions for Window Repair vs. Replacement

By David Boyer, Ron Tatley, and Paul Grahovac

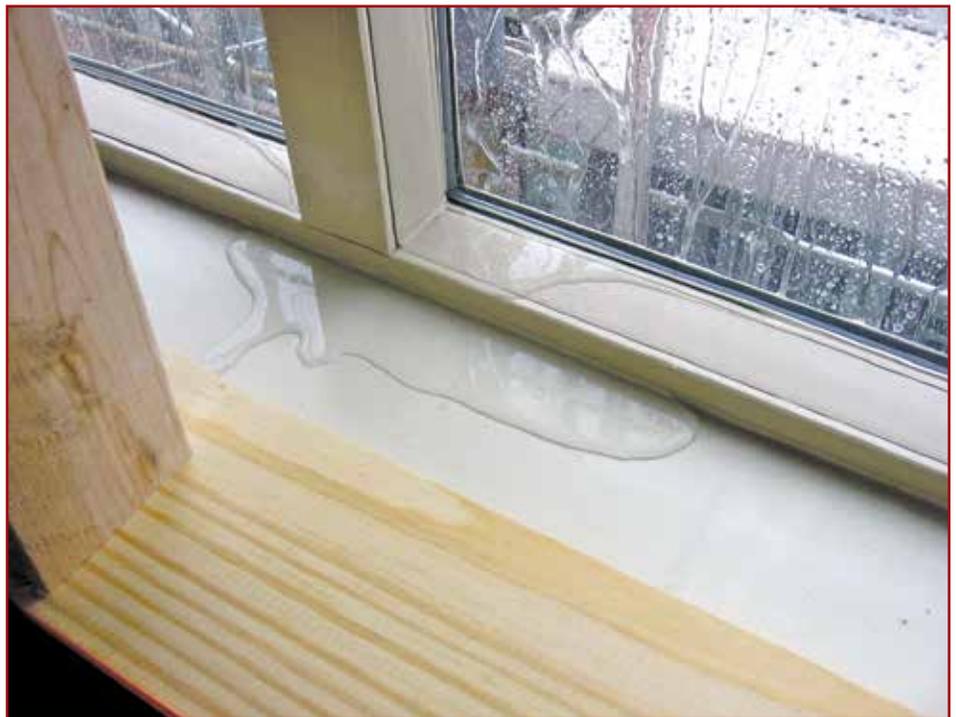
Figure 1 – A puddle beneath the window causes most property owners to suspect windows are leaking. When simple efforts to stop the leakage fail, many surrender to the costly cycle of window replacement.

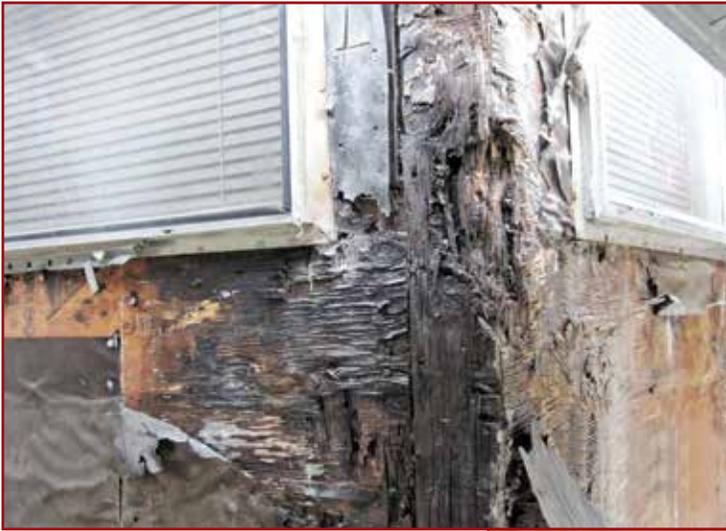
Figure 4 – The leak that got away.

Minor leaks or condensation that may have gone unnoticed just a generation ago now accumulate within rough openings and the adjacent, air-sealed wall assembly. That water causes progressive decay of interior finishes or the structure itself. Once initiated, such water-related decay can quickly snowball out of control and cause mold growth (Figure 4).

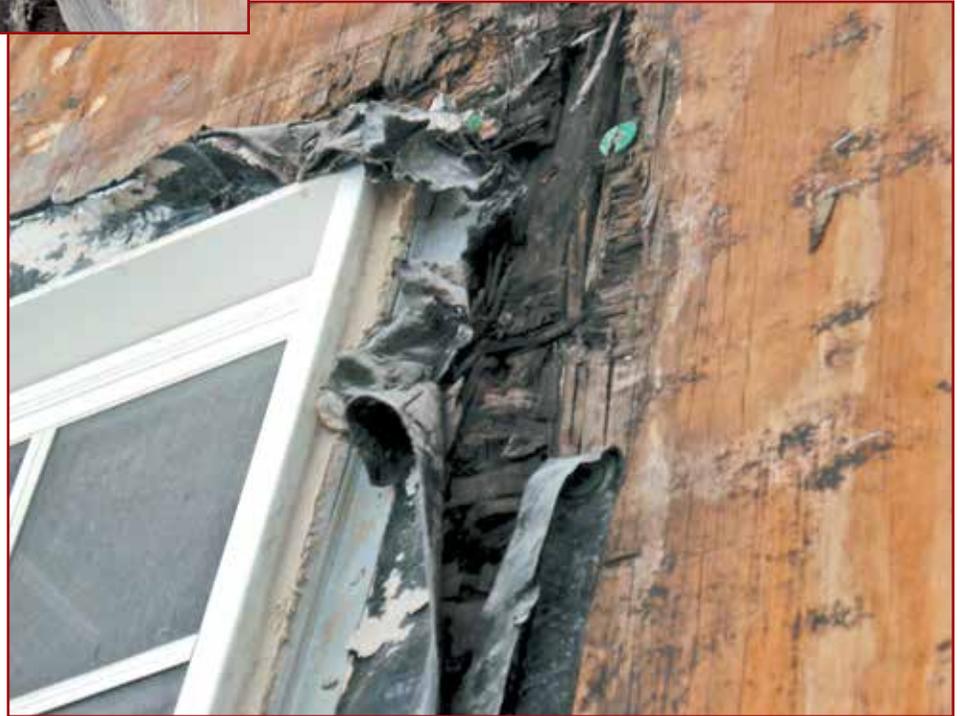
Figure 5 – Perimeter window flashing that performs as an air and vapor barrier prevents drying of water that is trapped or accumulates between the window and the rough opening.

air or rainwater than for their capacity to accommodate drying of water that may be present or accumulate within the walls (Figure 5).

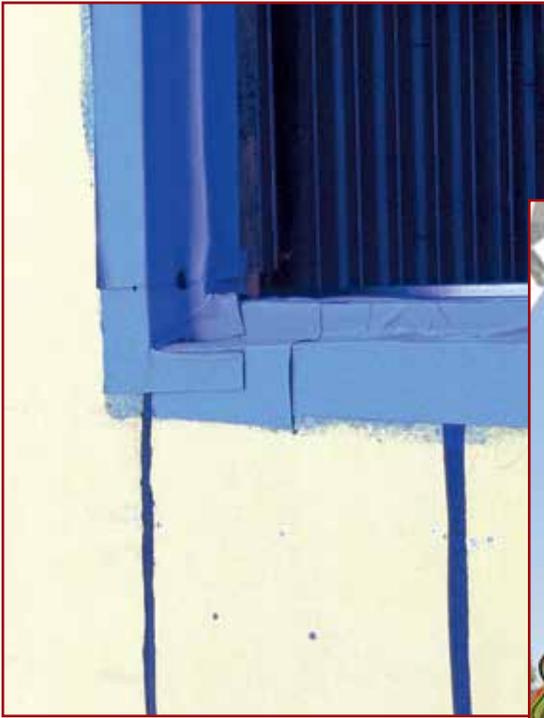
Figure 7 – When using a shingled series of straight and flexible flashing or both to waterproof the rough opening, it is easy to underestimate the impact several layers of thick membranes have on the distance between corners of the rough opening.

While such details seem logical on paper, many are impractical to execute and fail to consider the impact that several layers of thick self-adhering membranes have on the distance between corners of the rough opening (Figure 7).

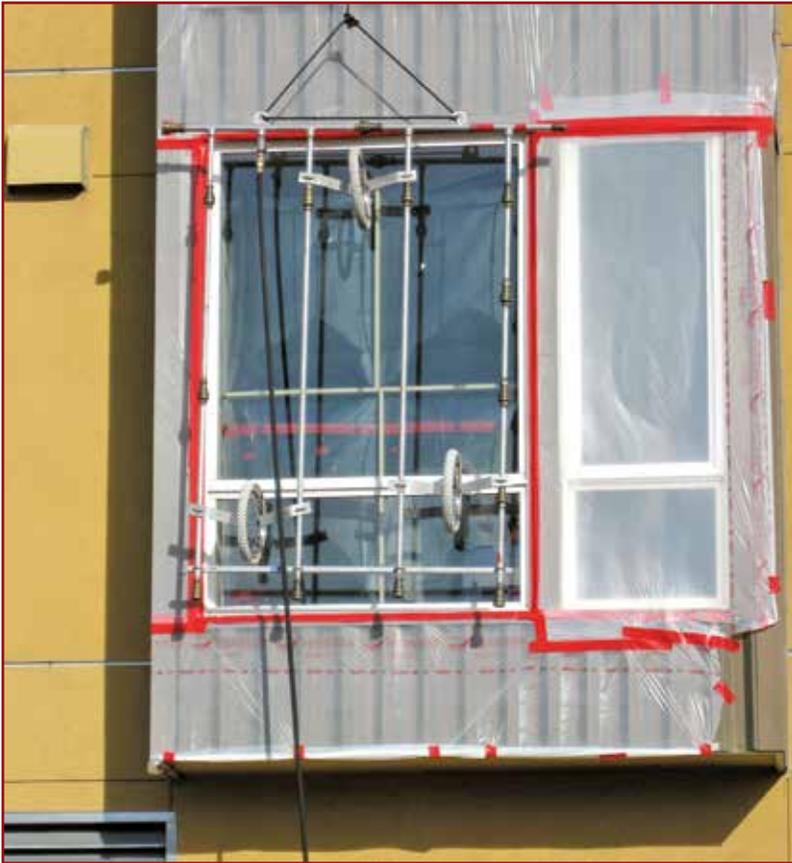
Figure 10 – In this photo, the joint between the window and the wall opening is masked to determine watertightness of the window unit. By masking the window unit and repeating this same test, the watertightness of the perimeter joint can be determined.

Such traditional pass-or-fail testing typically relies on external spray racks calibrated to deliver a minimum of five U.S. gallons of water per hour per square foot. These spray racks are calibrated to deliver six gallons per hour (*Figure 10*).

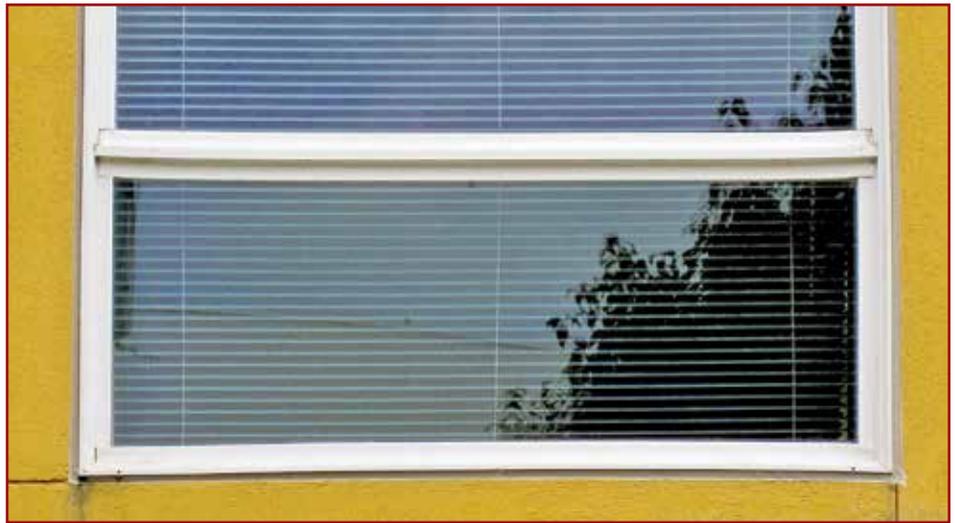
- Deformities in the horizontal mullions caused the glazing beads to exert uneven pressure on the underlying glazing tape. For some windows, glazing beads were cupped sufficiently to channel water into the window assembly, creating another complex pathway for water entry (Figure 14).

Figure 14 – Deformities in the horizontal mullions caused the glazing beads to exert uneven pressure on the underlying glazing tape. For some windows, glazing beads were cupped sufficiently to channel water into the window assembly, creating another complex pathway for water entry.

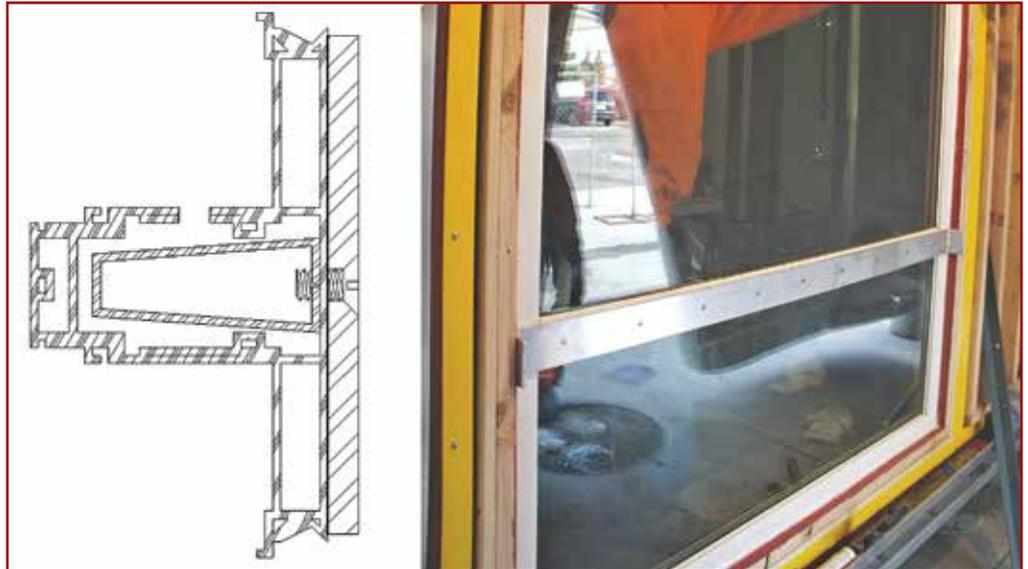
Figure 15 – Once installed on the repaired window, the aluminum strongback was tested and passed at 11.53 in. of water column (2,872 Pascals, 155-mph wind, or 60 lbf/ft²).

The higher test-pressure capabilities of the DVT chamber also made possible the design of an aluminum “strongback” to reinforce the critical horizontal mullions. Once installed, the strongback (*Figure 15*) allowed the repaired window to withstand pressure differentials that exceed the building’s structural design load and all of the window manufacturer’s original performance data... for the first time.

- Individual IGUs were temporarily removed.
- The horizontal mullions were heated to correct deformation.
- The aluminum strongback was bonded and mechanically fixed to the interior face of the horizontal mullion and the rough opening.
- The original setting blocks were installed at proper spacing.
- The original IGUs were reinstalled.
- An upgraded glazing tape with

- New glazing beads were installed.
- The interior face of the aluminum strongback was painted to match interior trim.
- Minor damage done to interior finishes was repaired and repainted.
