Doing It Right the *Second* Time –

Designing Minimally Invasive, Cost-Effective Solutions for Window Repair vs. Replacement

By David Boyer, Ron Tatley, and Paul Grahovac

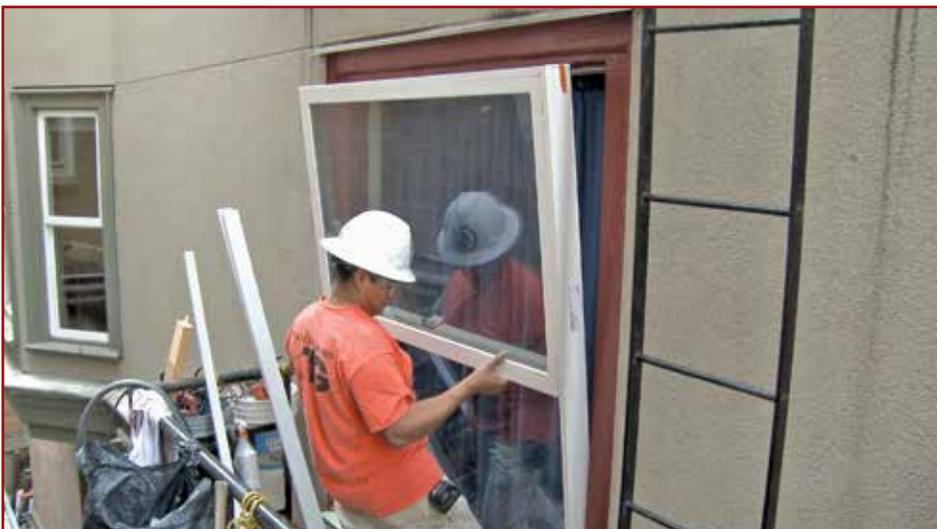
conditions, executing those details under less-than-ideal weather conditions can be challenging. Factor in contractors pressed to stay on tight construction schedules using inexperienced labor and outmoded materials, and it’s easy to understand why a higher number of windows—even better-performing windows—increases the likelihood of water penetration in modern buildings (*Figure 3*).

Figure 3 – Want to know why a window leaks? Install windows.

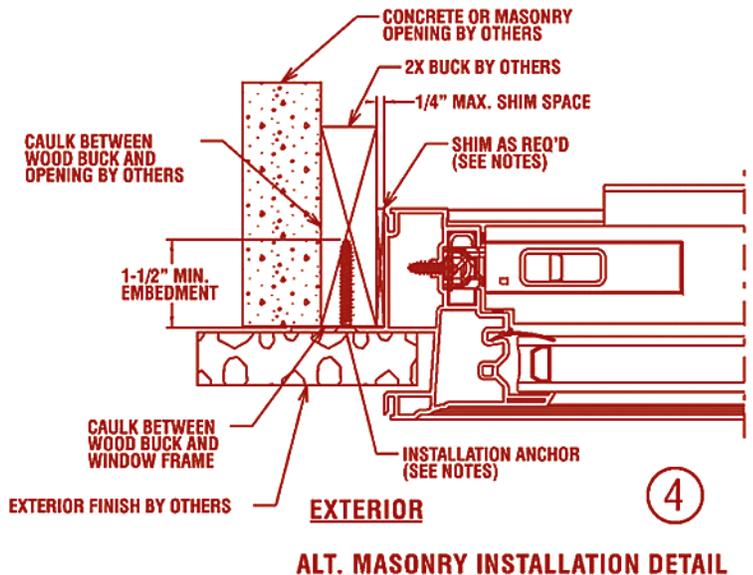
Figure 6 – Popular window installation detail.

On projects in which Tatley-Grund is involved, the rate and severity of window failures caused by a poorly designed marriage between the window assembly and the structural wall are increasing. Either the connections are not continuous, or the materials used to execute those connections are incompatible with one another or incompatible with conditions under which most construction is carried out (Figure 6).

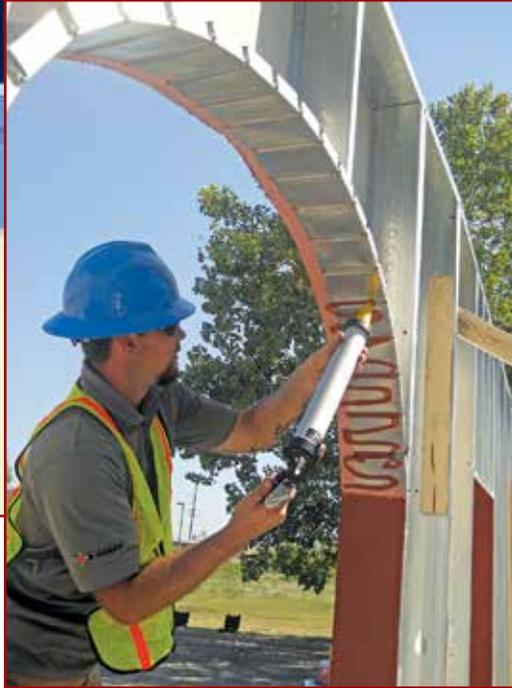
While such details seem logical on paper, many are impractical to execute and fail to consider the impact that several layers of thick self-adhering membranes have on the distance between corners of the rough opening (Figure 7).
